NRL/MR/6120--97-7957

Control of Lead in Drinking Water

13. ABSTRACT (<i>Maximum 200 words</i>) This report describes the installation of an NRL-developed epoxy lining in the drinking water distribution system in three buildings. Water was sampled before and after installation of the lining; the sampling data was interpreted after several confounding factors were identified and allowed for. Improper installation of the lining in one of the buildings led to its premature failure, and this was documented and analyzed. The lining is shown to be effective in preventing leaching of lead into drinking water. This technology is recommended as a routine method for excluding lead from drinking water distribution systems in buildings, and guidance for use in establishing contracts to install the lining is provided.

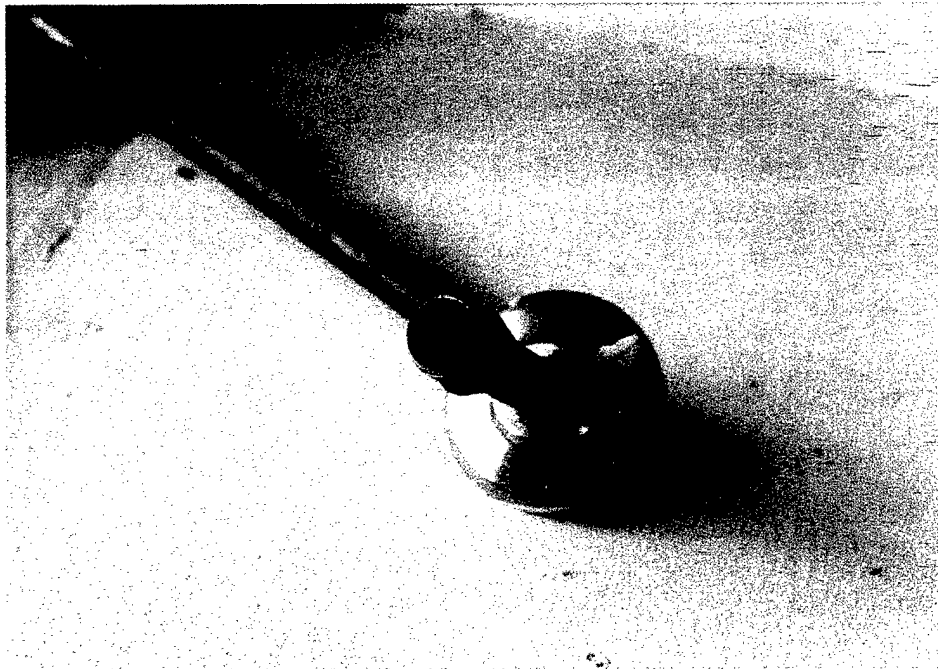
Some of the feed lines to bathroom taps were blocked with debris. Figure 3 shows the hot water line just behind the tap in room 214; this debris was packed hard and more than 3/4" deep.

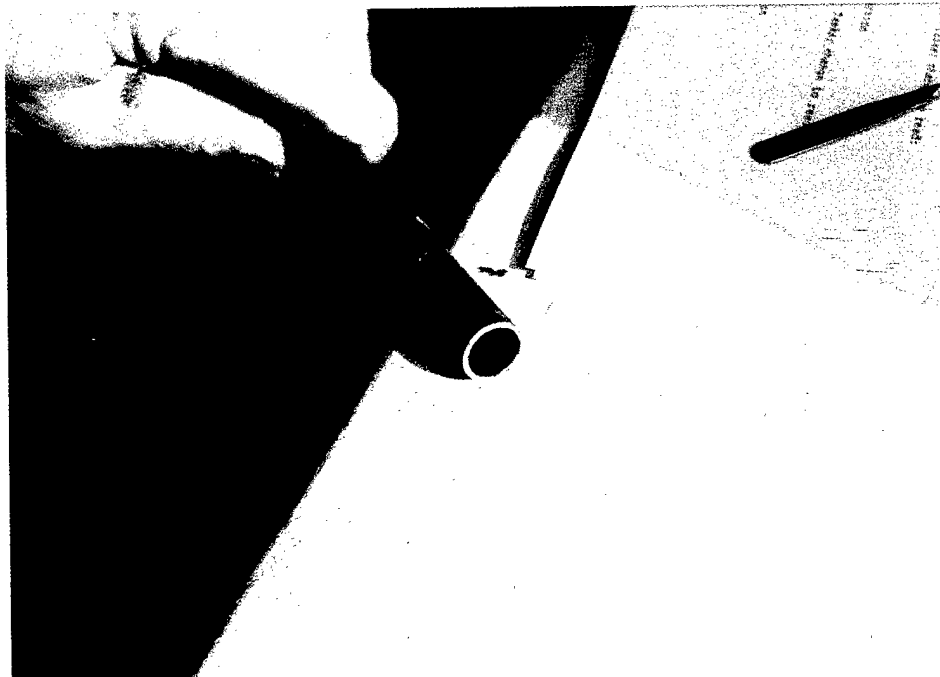
Figure
4

Paint in the cold water riser to room 214 was rippled, indicating that it sagged before drying; thickness is reasonable but the paint has entrained grit which makes it rough (Figure 4). Where this line became horizontal and entered the main, the coating was thicker on the bottom of the main (Figure 5).

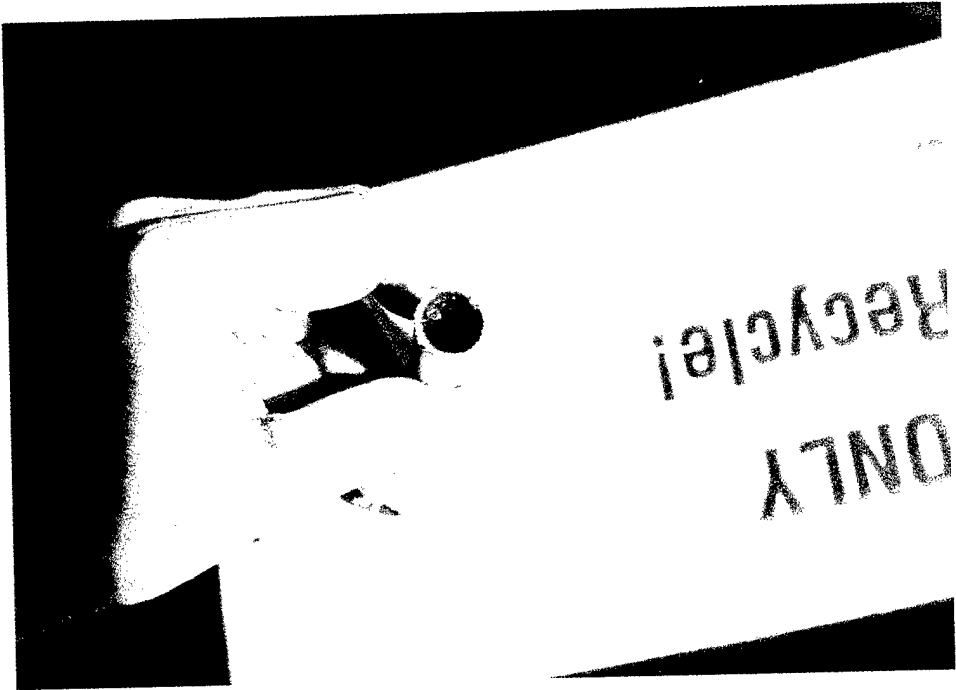
Figure 6

The cold water line to room 211 showed proper thickness and good adhesion, but contained much entrained grit (Figure 6). Some of the pipes, such as the cold water feed in room 210, contained excessively thick coating or no coating at all. In the cold water line to room 206, just behind the tap the coating is excessively thick and porous (Figure 7),

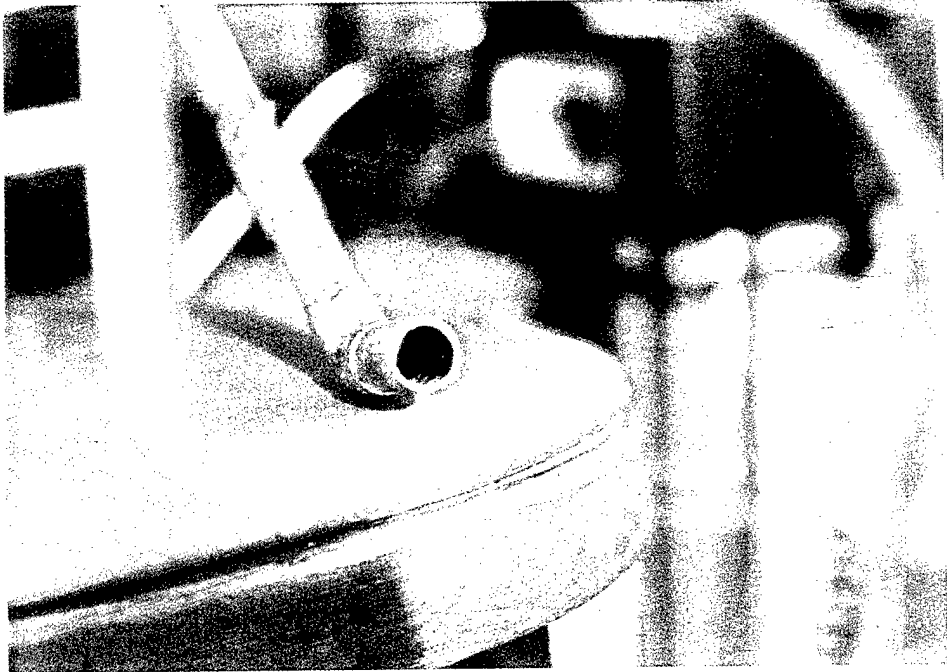
Figure 8

but 24 inches toward the main there is no coating at all (Figure 8). The cold water line (Figure 9) to the ladies room near the first-floor lobby and to room 207 was at the upper limit of thickness on the bottom and very rippled.

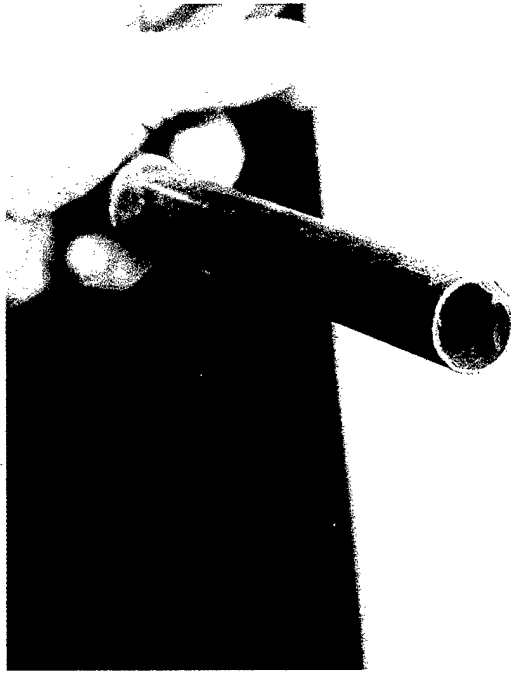
Figure
10

The hot water line leading to laundry on the first floor between room 107 and the booking office showed good adhesion, but the paint is excessively thick and severely rippled (Figure 10). The lining in the hot water pipe to room 106 (Figure 11) was at the maximum permissible thickness and showed ripples, good adhesion, and some evidence of grit in the paint.

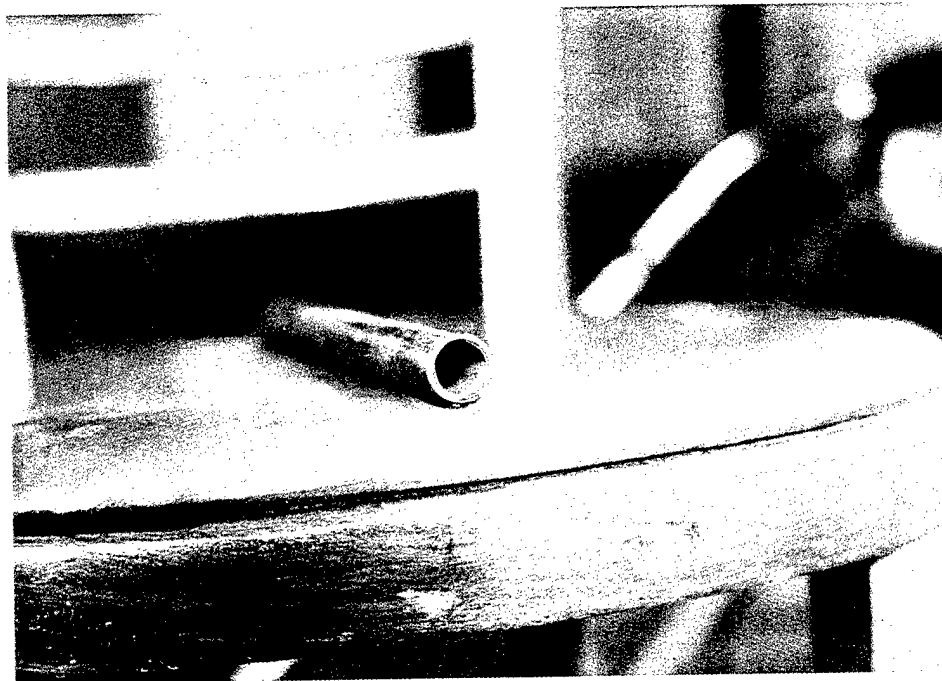
Figure
12

The lining in the cold water feed to room 105 (Figure 12) was excellent, showing proper thickness, good adhesion, and no contamination. Lining in the hot water line into room 101 was hard and smooth, adhered well, but was slightly thick on the bottom of the pipe nearest the tap (Figure 13).

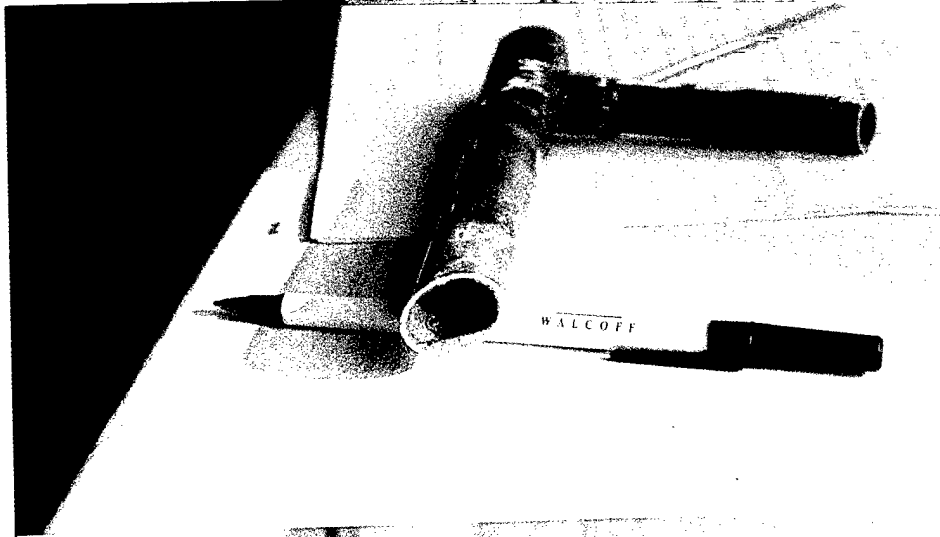
Figure
14

Workmanship in the cold water main is good at the north end but very poor at the south end. At the north end, the lining is generally smooth and glossy, with light rippling. Adhesion of the paint seems satisfactory. The paint is thicker on the bottom of the main at the north end of the building (Figure 14), but not so thick as to obstruct flow.

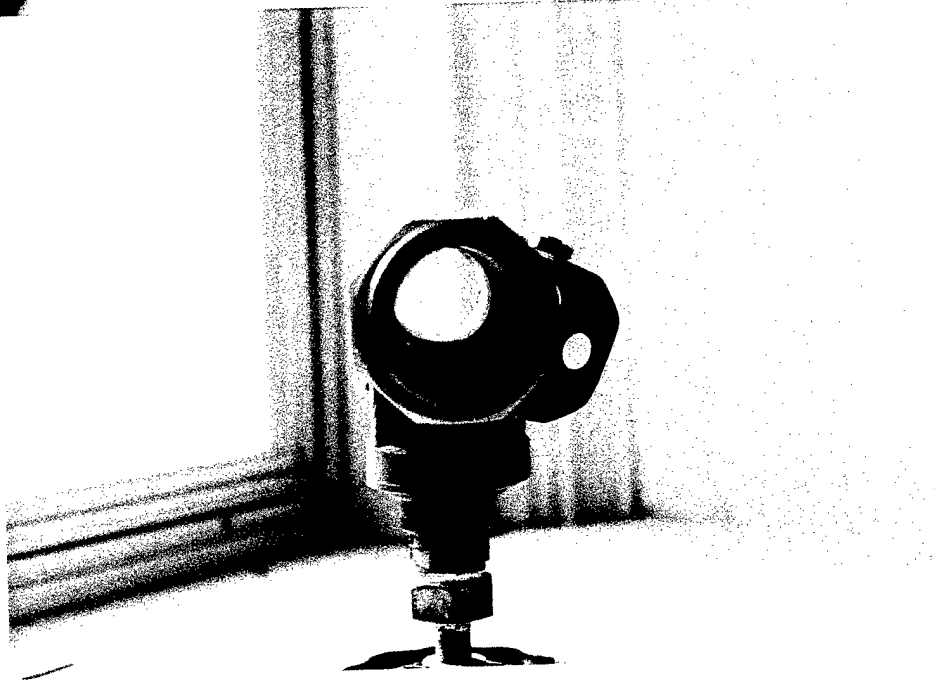
Figure 15 shows a valve and adjoining piping from the cold water main at the north end. The valve is operable but must pierce and crack paint in order to close. The coating is generally smooth, with light rippling but no blisters. Adhesion of paint seems satisfactory. Paint has a matte finish instead of the normal gloss.

All valves were painted, and most were inoperable (see Figures 15, 17 and 20 above). The contract explicitly required valves to be removed from the lines before painting.

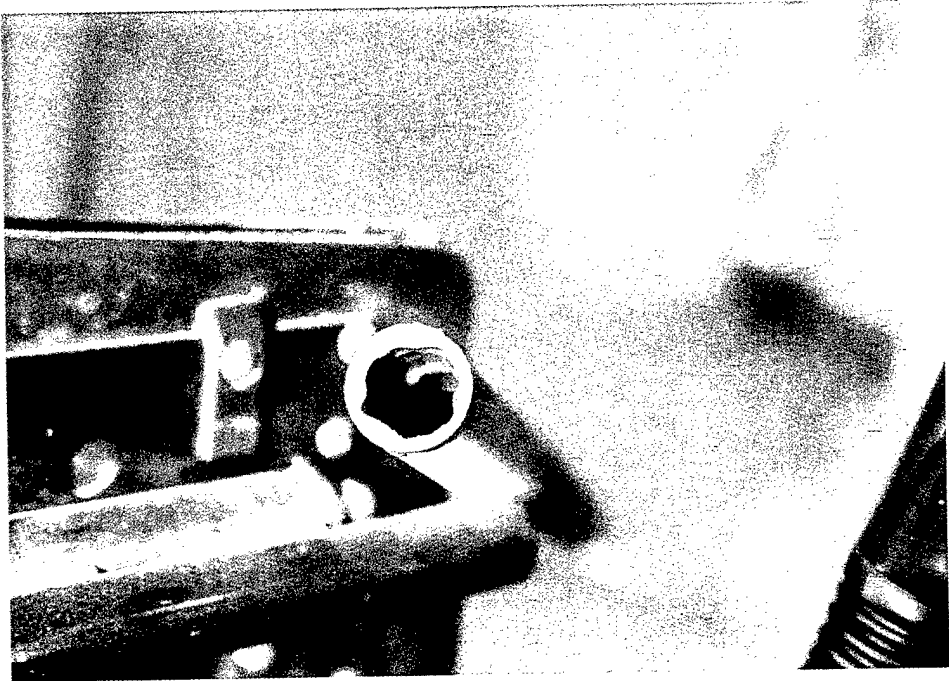
Figure 16

At the south end of the building, the paint is excessively thick and rippled (Figure 16). A valve in this line is painted open and cannot be operated (Figure 17).

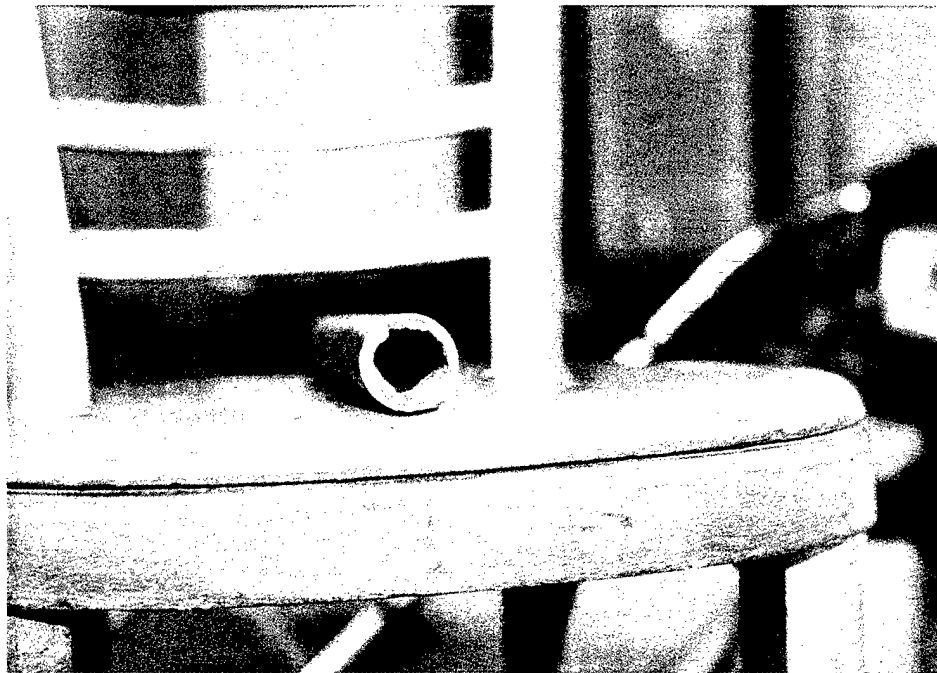
Figure
18

At the far south end of the building, the lining is excessively thick at one point, but stops abruptly leaving uncoated pipe. In a section of 1" cold water main from far south end of building, the paint is excessively thick at one end (Figure 18) but there is no paint at all at the other end (Figure 19). The roughness of the pipe surface at the uncoated end is very light on the bottom and sides, but there is no roughness at all on the top 60° of the pipe.

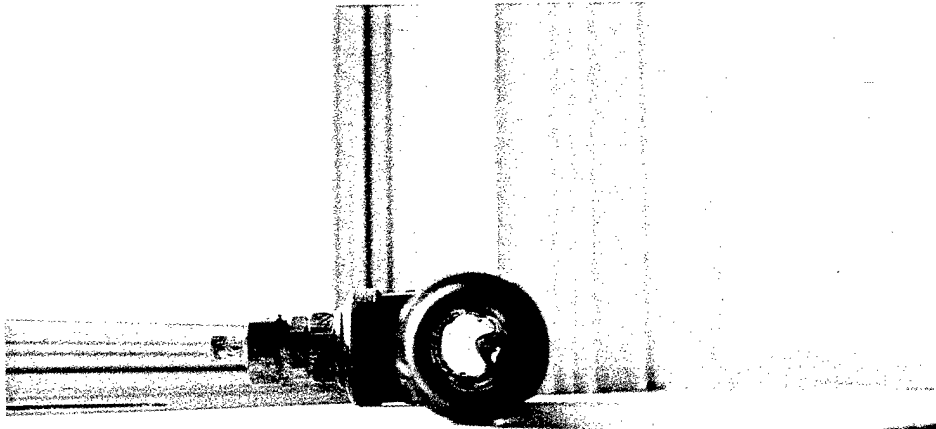
Figure 20 shows a section including a valve from the hot water main at the north end of the building. The thickness of paint in the pipe is acceptable, but the valve is painted open. A single blister about 8" long has formed at the top of the pipe. The interior metal surface of pipe is very smooth; there is no surface roughness at all.

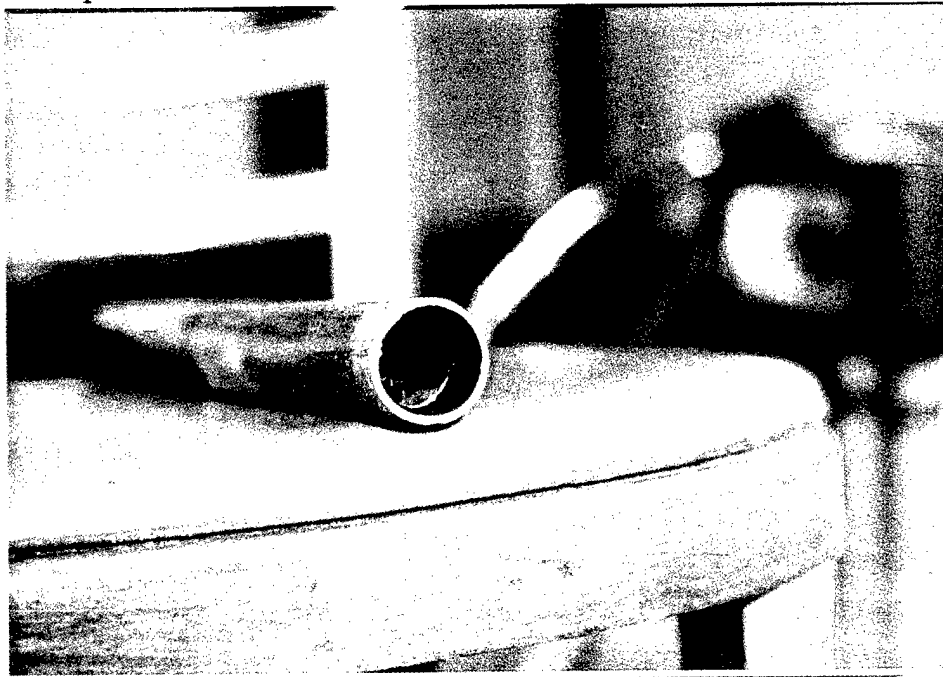
Figure 22 shows a section of pipe from the south end of the building. Adhesion to the bottom of the pipe is satisfactory, but paint on the sides and top of the pipe has lost adhesion to the metal and moved into the center of the pipe, where it may be broken loose by flowing water.

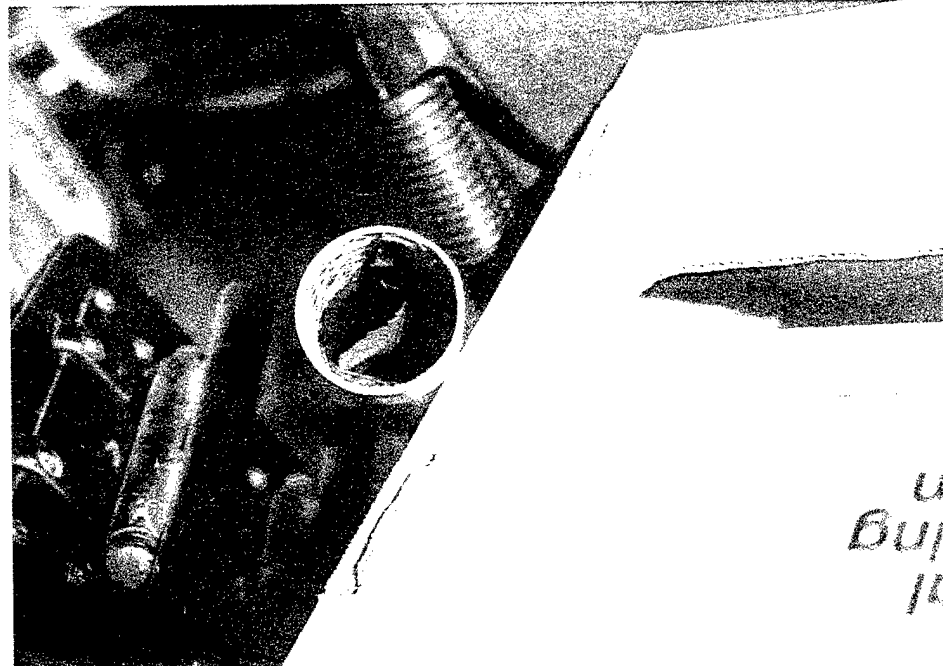
Figure 23 shows delamination of paint, leaving bare metal and flakes partially obstructing flow in hot water 2" pipe from ceiling in main hallway at south end of the building. The mottled black spots on the metal indicate that hot work has been done close to this site.

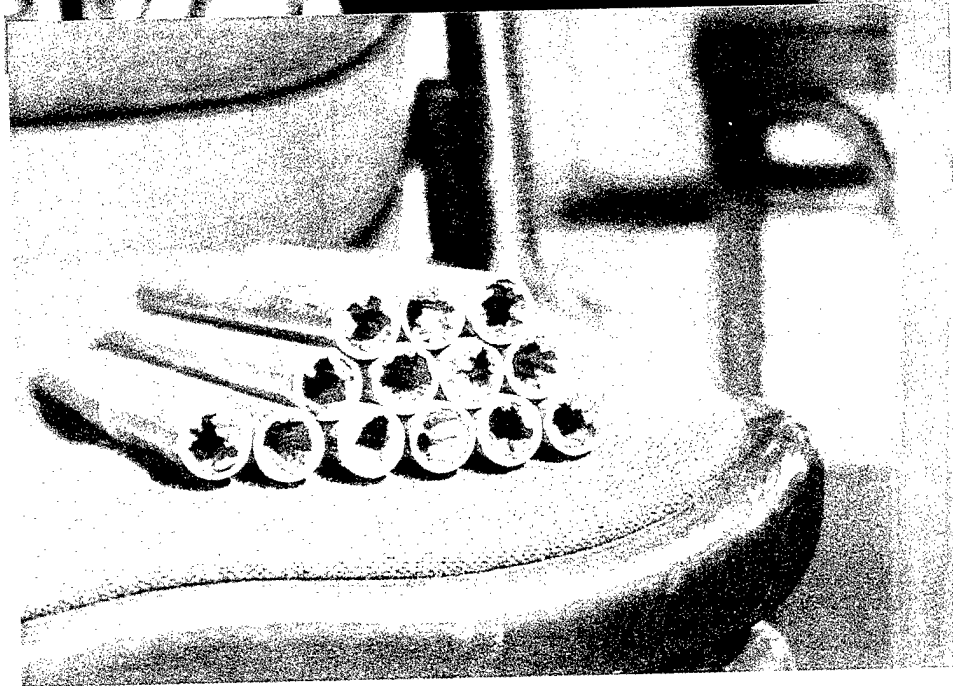
Figure
25

A 13-foot section of 3/4" hot water recirculating line from the far south end of the building was nearly obstructed by excessively thick paint. A pipe cutter was used to cut this pipe into 13 1-foot segments, and these are shown in Figure 25. The lining is not solid paint but is porous.

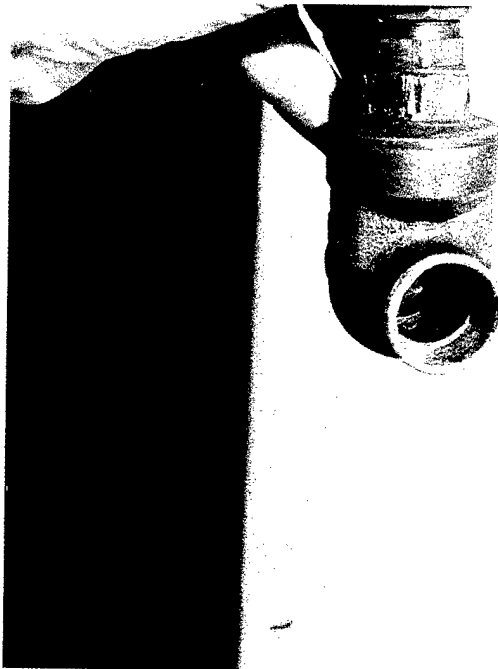
Figure 26 shows a valve from 3/4" hot water recirculating line which was not removed during painting. Paint covers the seat of the valve and prevents the valve from closing.

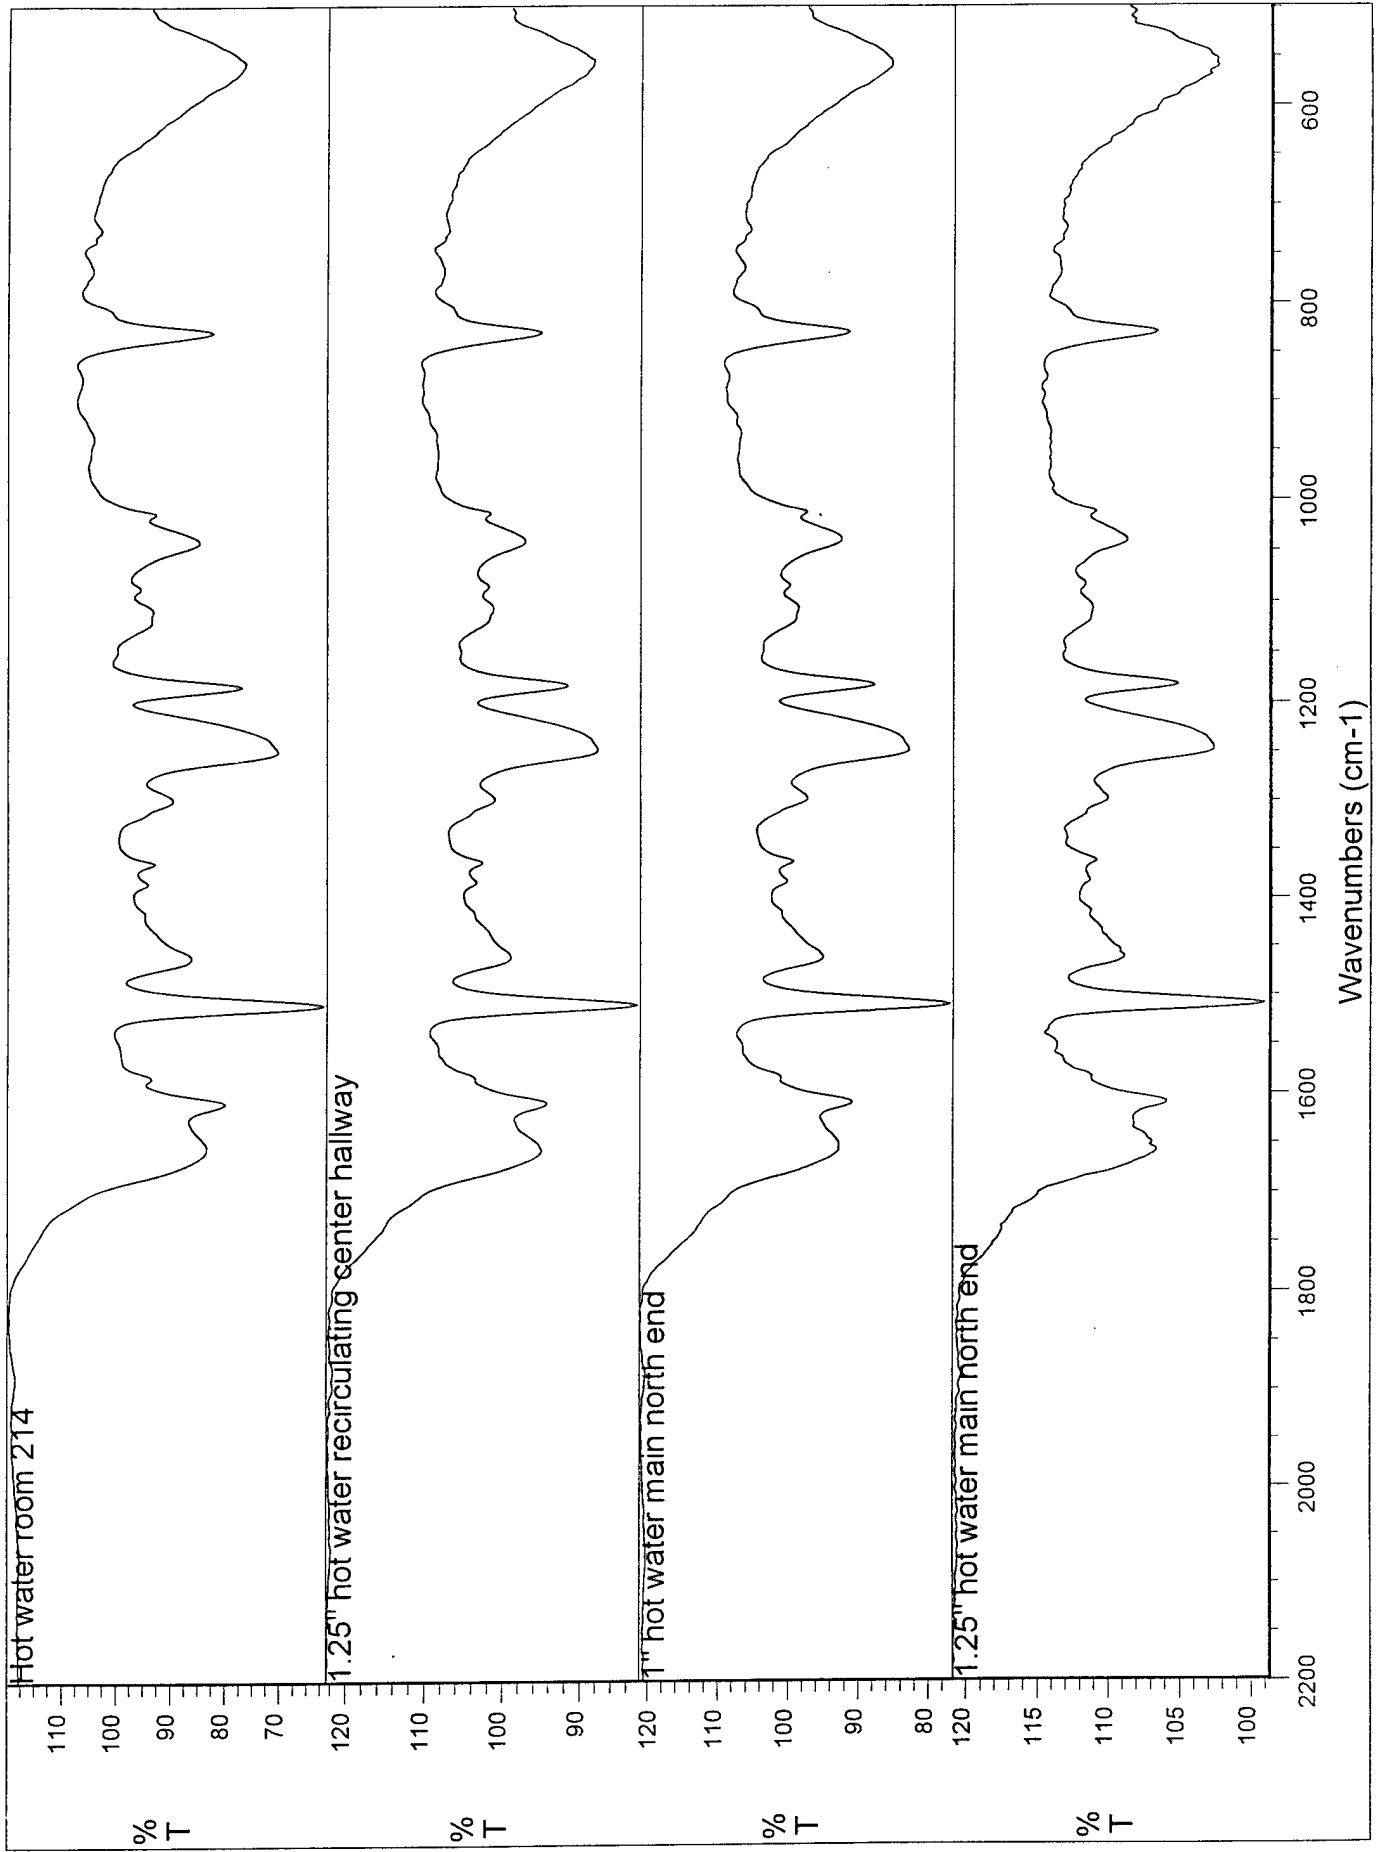
Manufacture and mixing of the lining. Infrared spectra of paint flakes were used to determine if the paint was manufactured properly and mixed properly. Figure 27 shows spectra of lining from four places in the building. The position and intensity of the peaks shows that the paint was properly manufactured and mixed.
