Moody Towers, University of Houston

CASE STUDY

Potential Water Crisis Averted – CuraFlo® Revitalizes Dormitory Piping at University of Houston

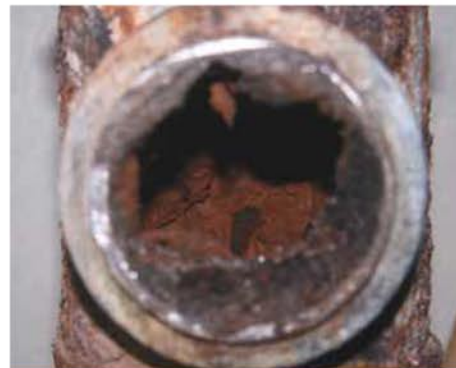
Tuberculation or build-up of scale inside a galvanized pipe reduces internal pipe diameter, consequently affecting water flow and water pressure

LeMaire and Turner recommended a combination of epoxy lining and pipe replacement in areas where existing pipe was too eroded to line. Their recommendation ensured a sturdy, long-lasting solution for the towers – and a quick turnaround to meet UH's strict timetable.

Workers then dried the pipes with pressurized hot air. Next, pipe interiors were "sandblasted" with specialized particles to remove all debris and mineral build-up and prepare the internal surface of the water pipe for bonding with the epoxy. From there, workers flowed epoxy into and through all pits, crevices, pinholes and fractures, bonding it to the cleaned and prepared walls of the pipes and creating a seamless, permanent, protective barrier. The inside of the pipes were coated with CuraPoxy at an average thickness of 16 mils. After the coating cured, a pressure test was applied at 120 psi to assure a leak-free system.

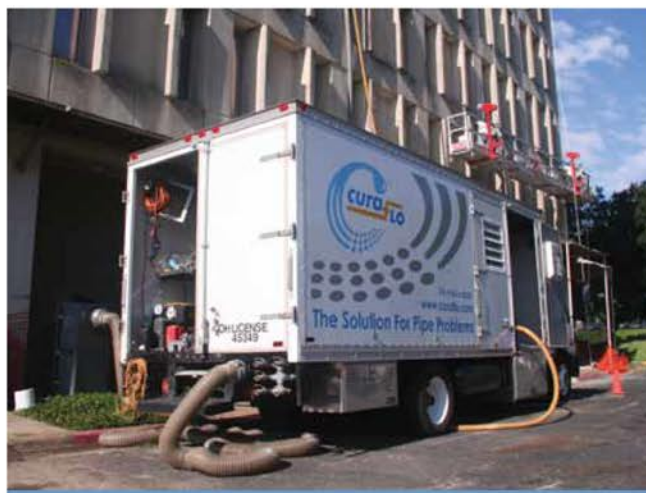
CuraFlo uses state-of-the-art equipment to complete lining projects as effectively and quietly as possible.
